# Manhole Inspection Summary

Manhole # S21M1\_001MH

Insp Date: **5/1/08 12:11 PM**

**Location** Address: **2319 w patapsco av**

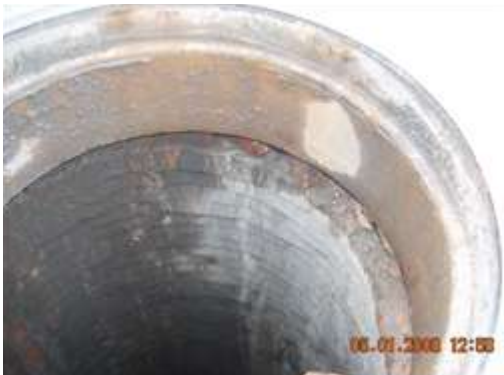
Misc.

inflow evidence

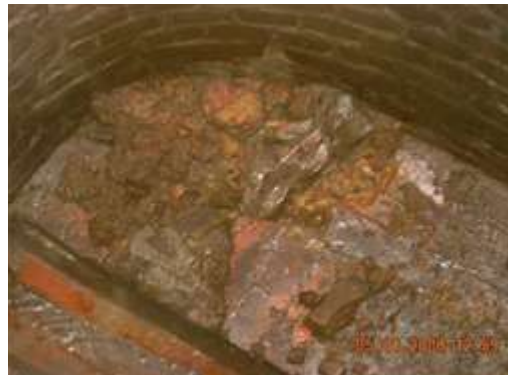
Defect 4

Condition: ☐ Sound ☐ Cracked ☐ Root Intrusion ☐ Deteriorated ☐ Leaks ☒ **Debris**

debris on bench

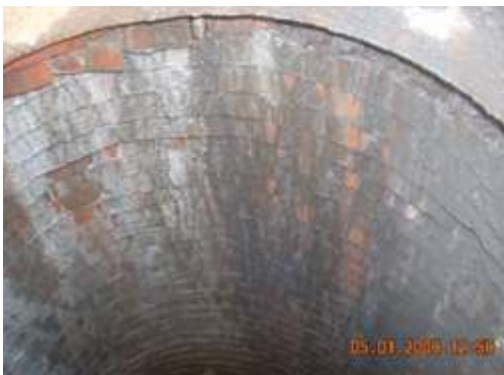
Defect 3

Infiltration: ☐ None ☒ **Joint** ☐ Cracks ☐ Mortar ☐ Roots ☐ Wall

infiltration @ chimney/frame joint

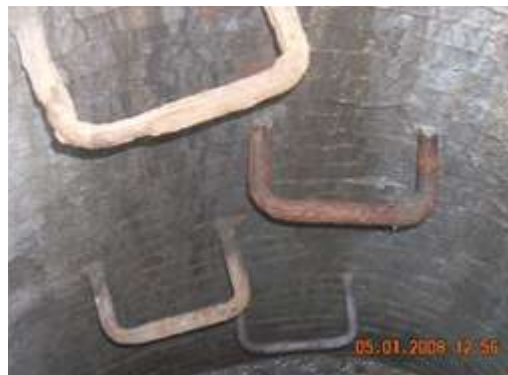
Defect 2

**Steps** Count: **4** Missing: **0** ☒ **Corroded**

corroded steps

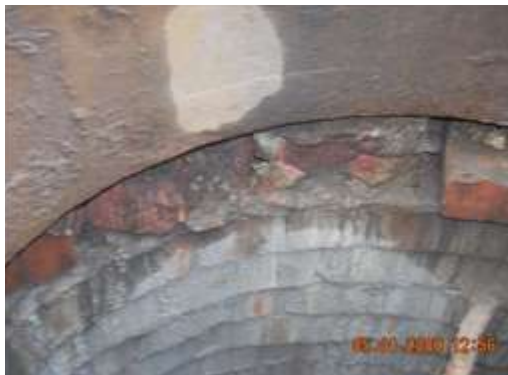
### Defect 1

Condition: ☐ Sound ☐ Cracked ☐ Root Intrusion ☒ **Loose Brick** ☒ **Deteriorated**

loose bricks, deteriorated chimney

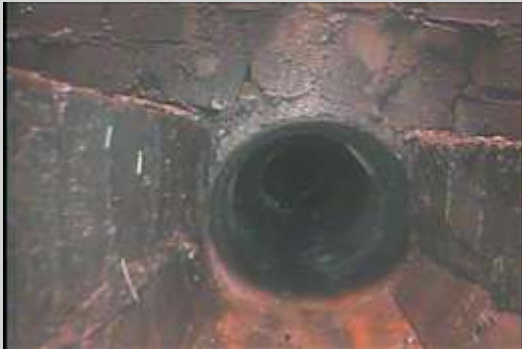
12 O'Clock Outflow

8 in. Circular Gravity Sewer  
Pipe Out @ 12 O'Clock

Pipe Height: **8.4** (in.) Rod and Bar (Angled)  
Pipe Material: **Clay** ☐ Pipe Lined  
Invert Depth: **8.10** (ft.) Flow Characteristics: **Slow**  
Deposits: ☒ None ☐ Mud ☐ Sludge ☐ Debris ☐ Grease  
Silt Depth: **0** (in.) Deposits Extent:  
Infiltration: **None** Pipe Seal Cond: **Sound**

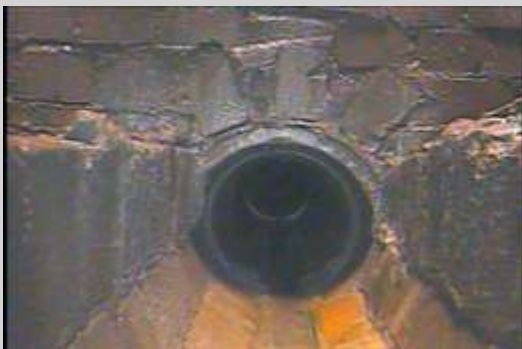
6 O'Clock Inflow

8 in. Circular Gravity Sewer  
Pipe In @ 6 O'Clock

Pipe Height: **8.4** (in.) Rod and Bar (Angled)  
Pipe Material: **Clay** ☐ Pipe Lined  
Invert Depth: **8.02** (ft.) Flow Characteristics: **Slow**  
Deposits: ☒ None ☐ Mud ☐ Sludge ☐ Debris ☐ Grease  
Silt Depth: **0** (in.) Deposits Extent:  
Infiltration: **None** Pipe Seal Cond: **Sound**
